SLIPPERINESS ON CONTAMINATED ROAD SURFACES – DIESEL SPILLAGE AND LOOSE GRAVEL ON BARE ASPHALT

Investigation for the Swedish Motorcyclists Association, SMC

Final Report

Project no: 10249764	Road Slipperiness on Contamination

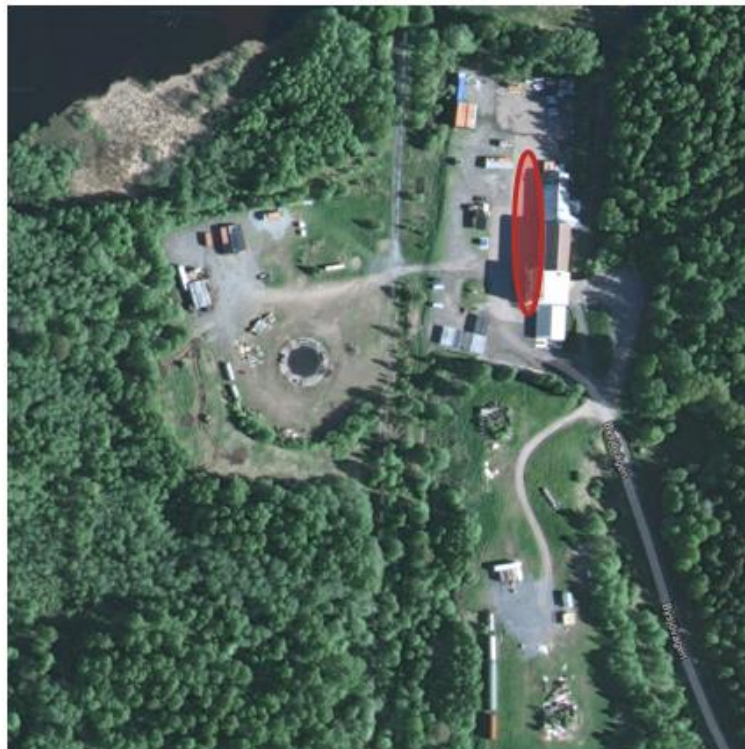
Figure 1 Bysjön Rescue Education Centre with the friction test section in red

Spilling several liters of diesel fuel by intention is due to environmental reasons prohibited on normal paved surfaces. Furthermore, a fenced and gated area is needed to make this kind of road test in a safe and undisturbed way. Hence, the test was conducted at a facility used for harsh rescue and police outdoor training; the [Bysjön Rescue Education Centre](#) near Borlänge City. An aerial photo⁴ of the facility is showed in Figure 1, with the 50 m test section marked by a red oval ring. The asphalt pavement was old with many cracks and high variance in macrotexture and roughness condition, just as on many rural county-roads in Sweden.

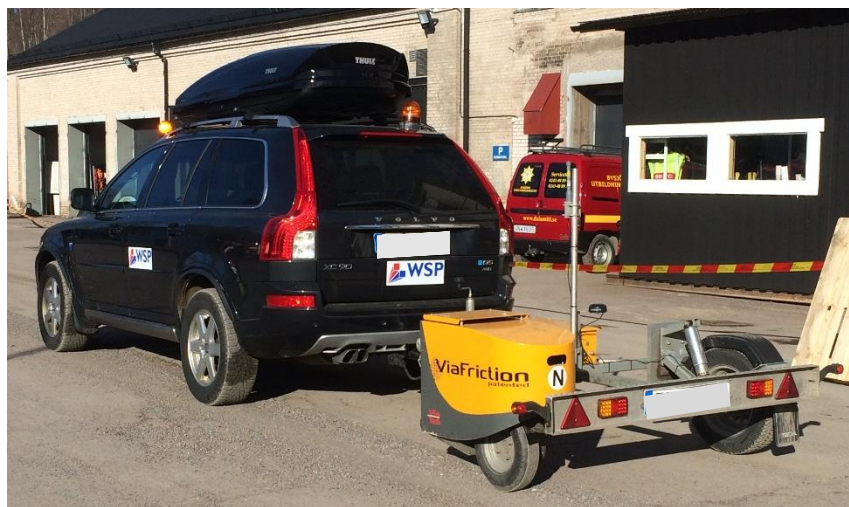
Figure 2 The ViaFriction trailer for measurement of road friction. Photo: J Granlund

The road friction numbers were measured with a car-towed device “ViaFriction”, see Figure 2. ViaFriction is annually calibrated and certified by the Norwegian Public Roads Administration. The test tyre was a 4.00 - 8 smooth tread reference tyre as specified in the American ASTM E1551 standard. The trailer was pulled by a 4WD Polestar-modified Volvo XC90, with good acceleration performance also on slippery road surfaces. The target operating speed was 35 km/h. Slip was set fixed at 20 %.

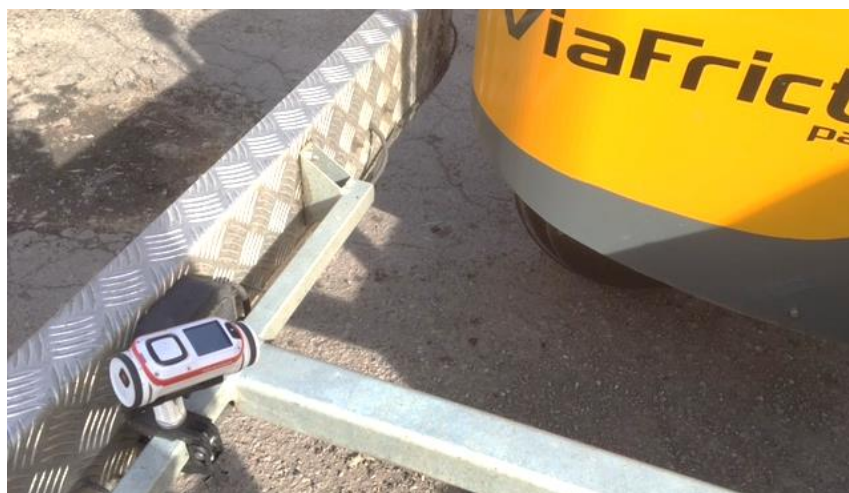
Figure 3 The HD Action Camera. Photo: P Holmlund

The project wanted to register if any significant lock occurred of the friction measurement wheel when testing slipperiness on the loose gravel. Therefore, the measurement trailer was equipped with a TomTom Bandit Action Camera, see Figure 3, filming at 30 frames per second.

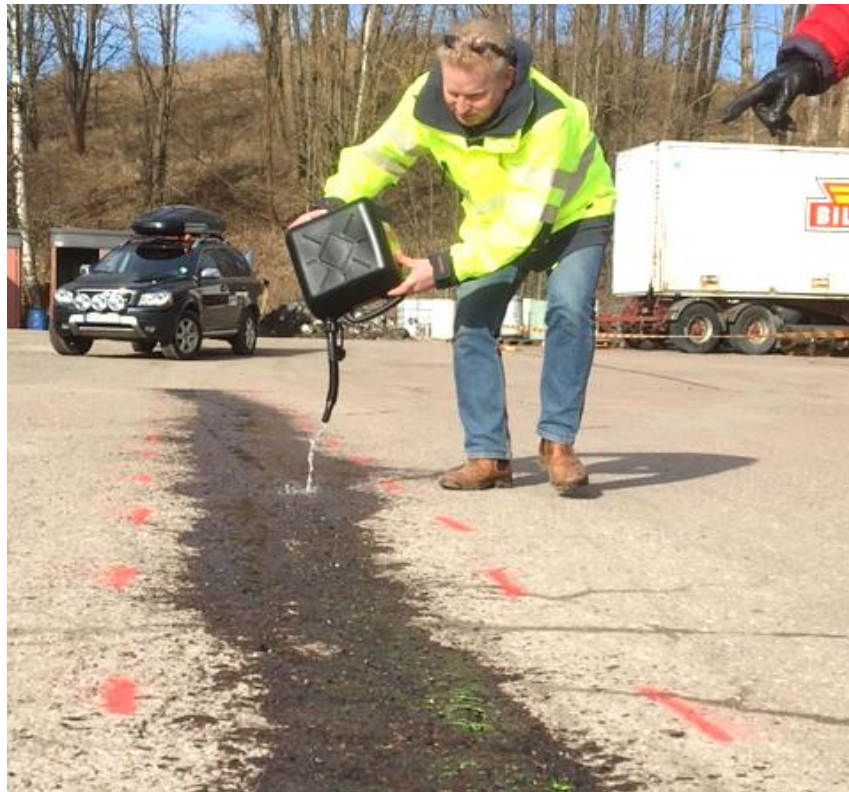
Figure 4 Spilling 10 liter diesel in the 20 m test section. Photo: P Holmlund

Preparation of the 20 m section for testing on diesel spillage is showed in Figure 4.

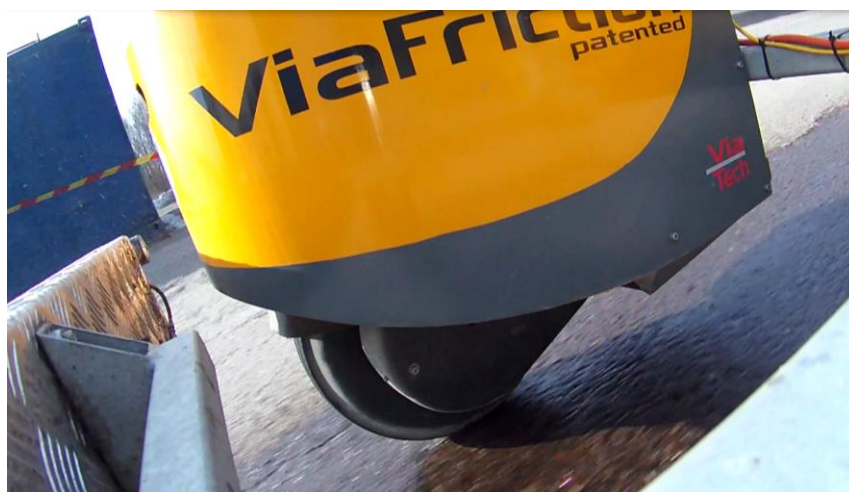
Figure 5 Action photo taken during measurement on diesel spillage

An example of action photo, taken when measuring on diesel spillage, is showed in Figure 5.

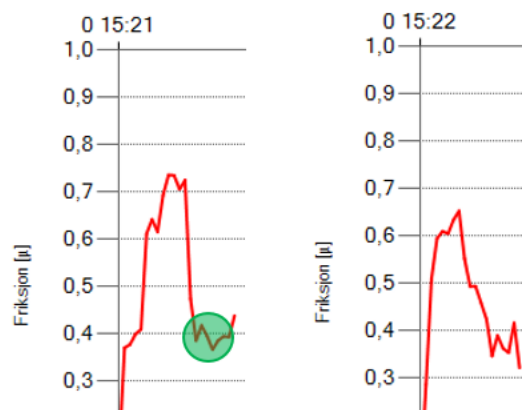
Figure 12 Friction numbers on 20 m diesel spillage, two runs

The project team had an idea that diesel spillage may become even more slippery, if it rains on it. Therefore, the testing ended with a set up where the diesel spillage was gently watered from a water hose. After allowing the diesel to become diluted by the moisture for fifteen minutes, two finishing measurement runs were done; one in each direction. The results are showed in Figure 12. Within the test section, friction numbers were in the range 0.32 to 0.43. These results are within the variance of the above results for slipperiness on non-watered diesel spillage. These results therefore does not support the hypothesis that water can significantly increase the slipperiness on diesel spillage.
