# MOTORCYCLE IMPACTS TO ROADSIDE BARRIERS – REAL-WORLD ACCIDENT STUDIES, CRASH TESTS AND SIMULATIONS CARRIED OUT IN GERMANY AND AUSTRALIA

Paper Number 05-0095

## ABSTRACT

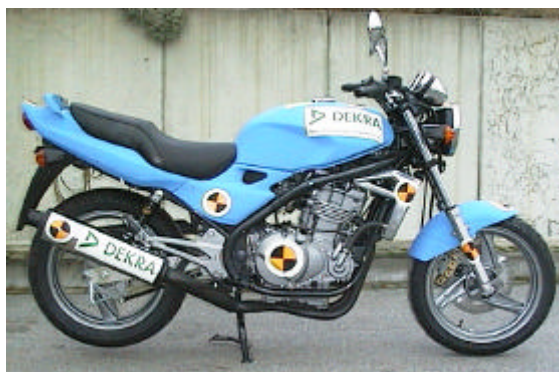
All tests were carried out with the same make, model and type of motorcycle being a Kawasaki ER 5 Twister (Figure 5.). The mass of the motorcycle itself was approx. 180 kg and approx. 272 kg with the dummy sitting on the motorcycle and wearing standard protective clothing.

**Figure 5. Motorcycle Kawasaki ER 5 Twister as used for all crash tests**

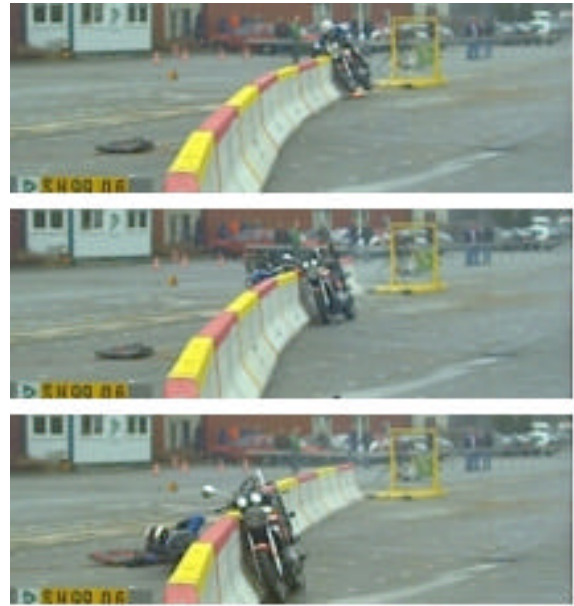
The concrete barrier (Figure 8) does not have any aggressive open shaped parts as in the case of the steel-based systems. In this crash test the motorcycle left the sled at 60 km/h prior to impacting the barrier. This was followed by the dummy flying over the top of the barrier. The dummy reached its final rest position on the opposite side of the barrier (Figure 8 and Figure 9). The distance of the final rest position from the point of first contact primary impact location was 26 m for the dummy and 38 m for the motorcycle.

**Figure 8. Full-scale crash test of a motorcycle impacting a concrete barrier protection system in an upright position prior to impact moving**

**Table 2. Measured dummy loads for the full-scale test shown in Figure 8**

The measured dummy loads again do not indicate any life-threatening injury risk (see Table 2.). The right femur is subjected to a compressive load of 4.5 kN being clearly below the injury limit of 10 kN.

Analysis of the film revealed that the motorcycle and the rider were effectively not decelerated during contact with the concrete barrier. As a consequence of this the risk of being deflected by the barrier into oncoming-traffic on the road is clearly higher than for a barrier protection system made from steel. Another disadvantage of concrete barriers is that during an impact they do not dissipate as much kinetic energy via deformation as the systems made from steel.

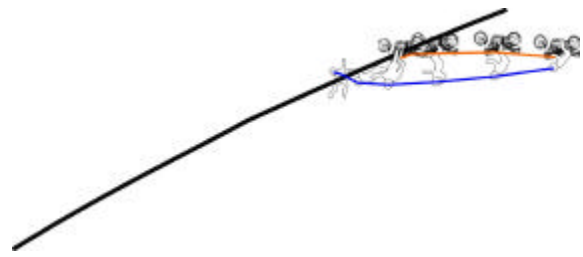
Figure 11 shows the trajectories of the motorcycle and dummy before and after impact onto the

protection system as determined from the analysis of the film from the overhead-view cameras.

**Figure 11. Trajectories determined from the overhead-view cameras of the motorcycle and the dummy before and after impacting the steel guard rail (Figure 10)**

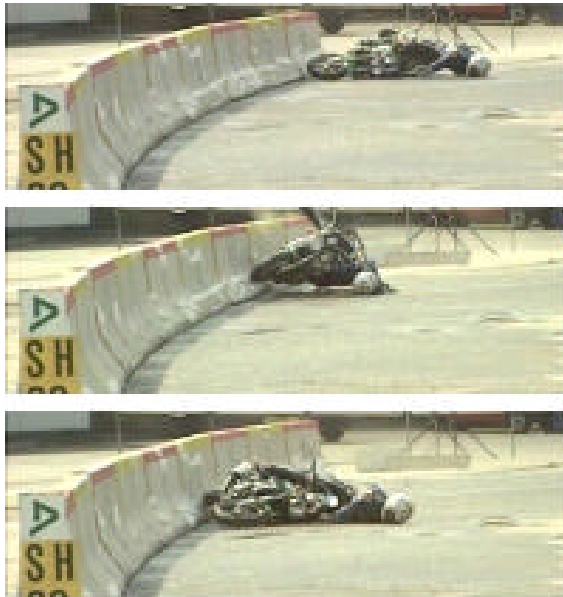
The impact where the motorcycle slides onto its side into the concrete barrier is shown in Figure 12. The motorcycle left the sled at 59 km/h and the front wheel impacted the barrier at 46 km/h.

**Figure 12. Full-scale crash test where the motorcycle impacts the concrete barrier protection system in a sliding position**

**Table 4. Measured dummy loads for the full-scale test shown in Figure 12.**

Some of the measured dummy loads related to the point of first impact into the protection system and to the second impact onto the ground are shown in table 4.

Deceleration of the motorcycle and dummy were not as rapid as during the impact where the motorcycle slid into the guard rail made from steel. Nevertheless the measured dummy decelerations for the primary impact were high, indicating a risks of severe and life-threatening injuries. The dummy head loads again lay clearly above the corresponding biomechanical limits.

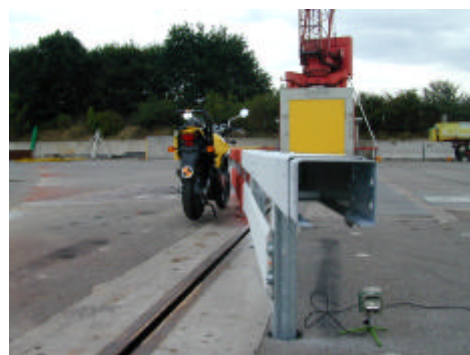
Figure 14 provides some information in regards to structure and the geometry of the modified system. The system is a so called “Schweizer Kastenprofil” consisting of sigma posts and a closed box-shaped profile at the top. An additional underrun protection board was mounted near to the ground to prevent both the direct impact onto a post and movement of the motorcyclist underneath the barrier protection system.

**Figure 14. Modified guard rail system with respect to better protection for impacting motorcyclists**

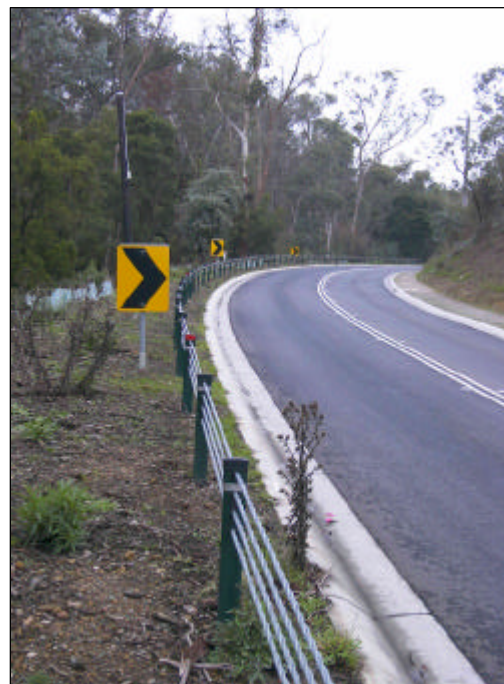
The wire rope barrier model was based on an actual installed system (Figure 20 and Figure 21). This barrier consisted of seven posts that supported the four wires of the barrier. The wires of the barrier that were modelled are made up of three high tensile steel cables woven together with an assumed yield stress of 500 MPa. They have a combined circumference of 60 mm and were represented in the model by a TRUSS2 finite element with a cross sectional area of 280 mm<sup>2</sup> for each cable. The wires had an initial tension setting of 5 kN. Ellipsoids were used to model the support posts being 2 mm thick.

**Figure 20 Four rope wire rope barrier**

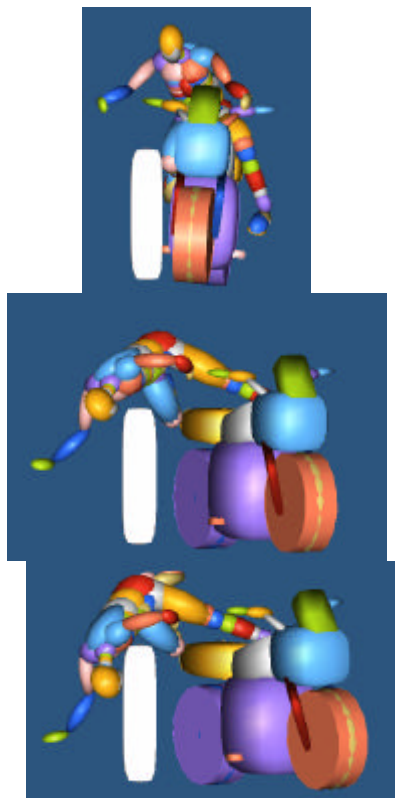
Table 7 shows the resultant injury criteria from the DEKRA crash test compared to the MADYMO simulation where the rider impacts the concrete barrier in an upright position. Impact kinematics for an upright motorcycle with a rider impacting the concrete barrier are shown in Figure 22. The rider kinematics when compared to Figure 8 look similar. However the motorcycle seems to rebound from the wall, indicating further refinement of the model is required if it is to accurately model the actual crash test.

**Figure 22 MADYMO simulation showing an upright seated rider on a motorcycle crashing into a concrete barrier at 60 kph and 12°**

At a shallow impact angle (12°) the resulting calculated injury for the head and chest indicate that some form of injury is probable but is below threshold limits.

In each simulation the dynamics of the rider's fall to the ground were different. Consequently each simulation produces different injury values. For example in the 25° collision at 80 km/h the rider does a full vault landing feet first rather than head first. Hence a slightly lower HIC value is obtained when compared to the slower speed collision at the same angle.
