DEFINITION OF A SAFE BARRIER FOR A MOTORCYCLIST

– a literature study

Maria Nordqvist, the Swedish Motorcyclists Association, SMC

May 2015

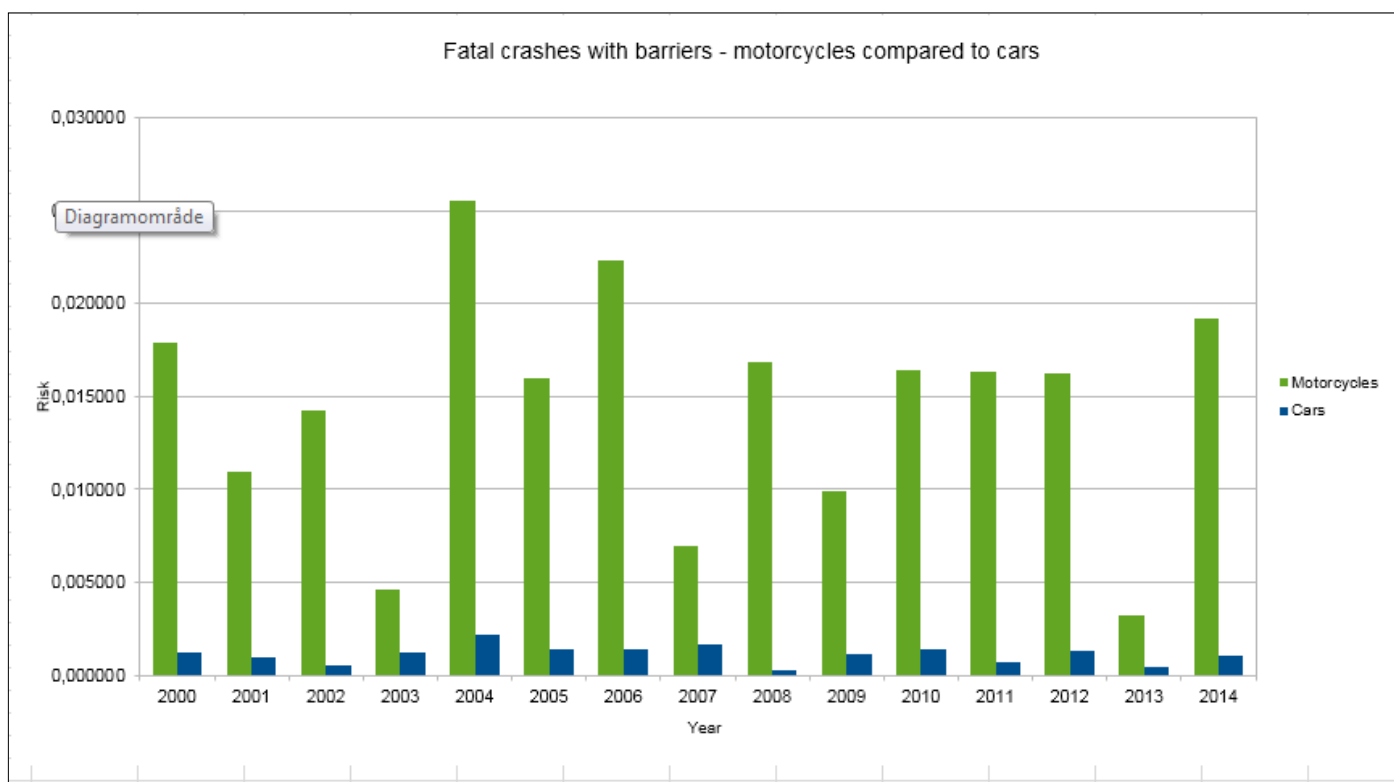
Figure 1. Risk per 1,000 vehicles of being killed in a barrier crash motorcycle/car 2000-2014. **Source:** The in-depth studies of fatal accidents, the Swedish Transport Administration and vehicle fleet SCB June 30 each year.

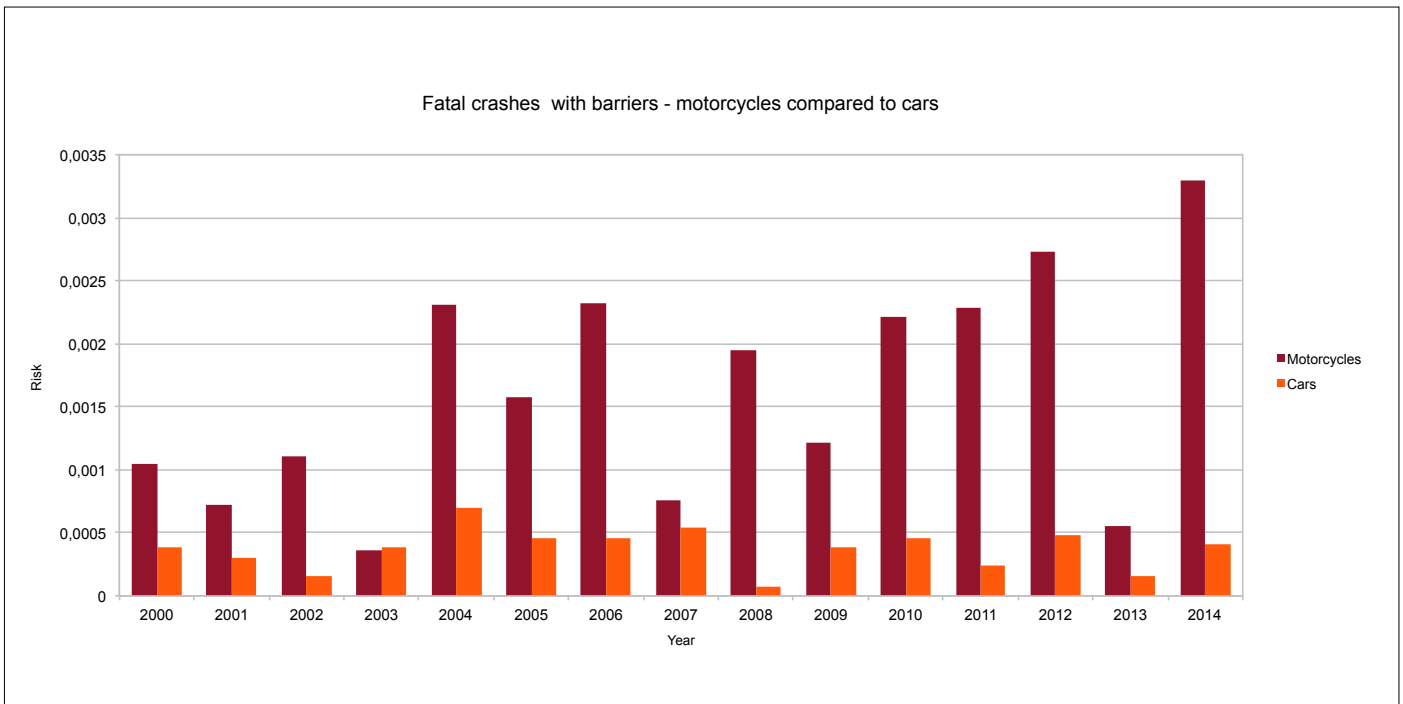
Figure 2: Risk per 1000 km of being killed in a barrier accident motorcycle/ car 2000-2014. **Source:** Swedish Transport Administration in-depth studies of fatal accidents and annual mileage according to Trafikanalys. Mileage for a car estimated for 2014. Mileage MC estimated for 2013-2014.

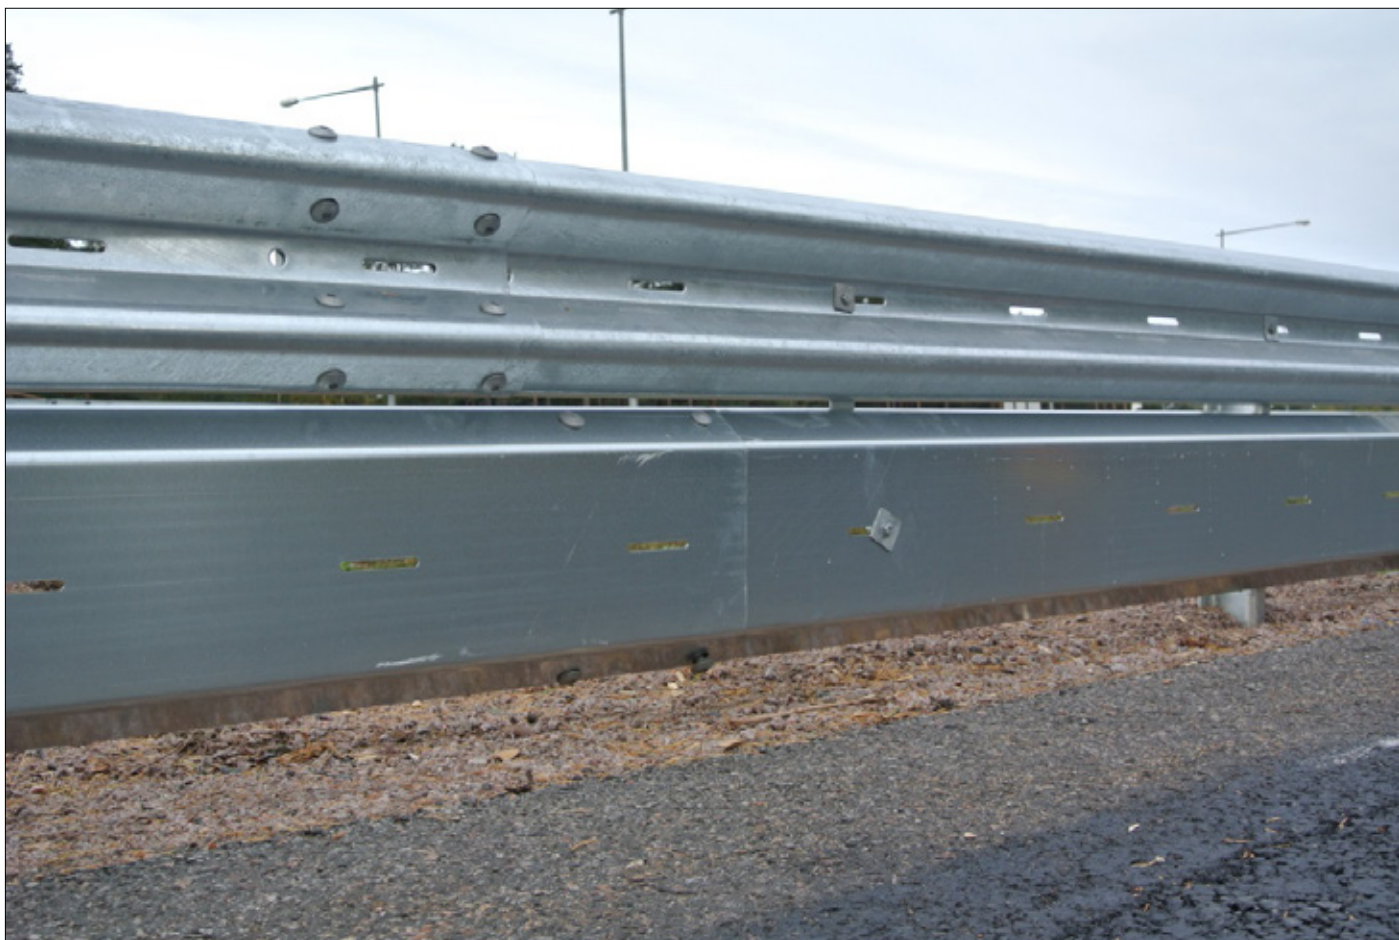
Picture 3. W-profile barrier with MPS, installed on an exit of E4 outside Gävle 2014.

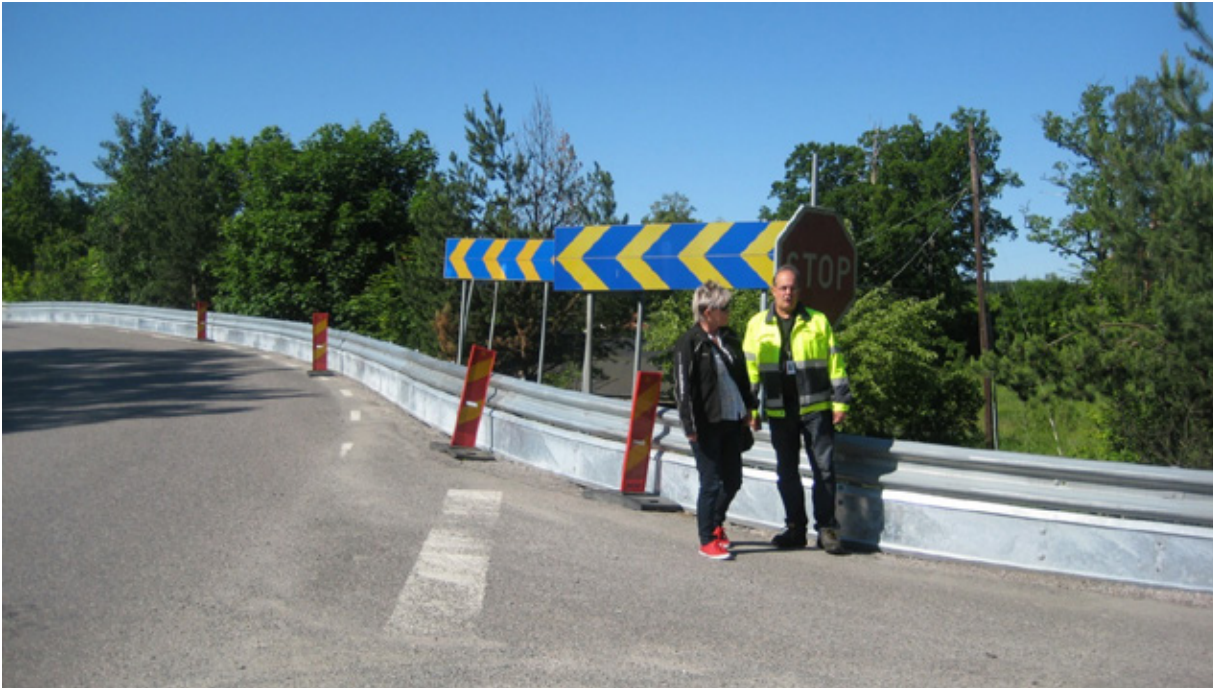
Picture 4. The first barrier with MPS was installed on a road outside Åkersberga May 2012.

The Swedish Transport Administration has installed MPS protection in 2012 in order to determine their resistance to damage during winter. After two winter seasons, it has not recorded any injury outcomes that would be a hindrance, in terms of longevity and maintenance, installation of this type of protection. There is an accumulation of debris, gravel and leaves on the ground against the side of the road, however, which is an effect that requires some increased maintenance compared with barriers without MPS. The trials will be completed and evaluated after this winter season, becoming the third.

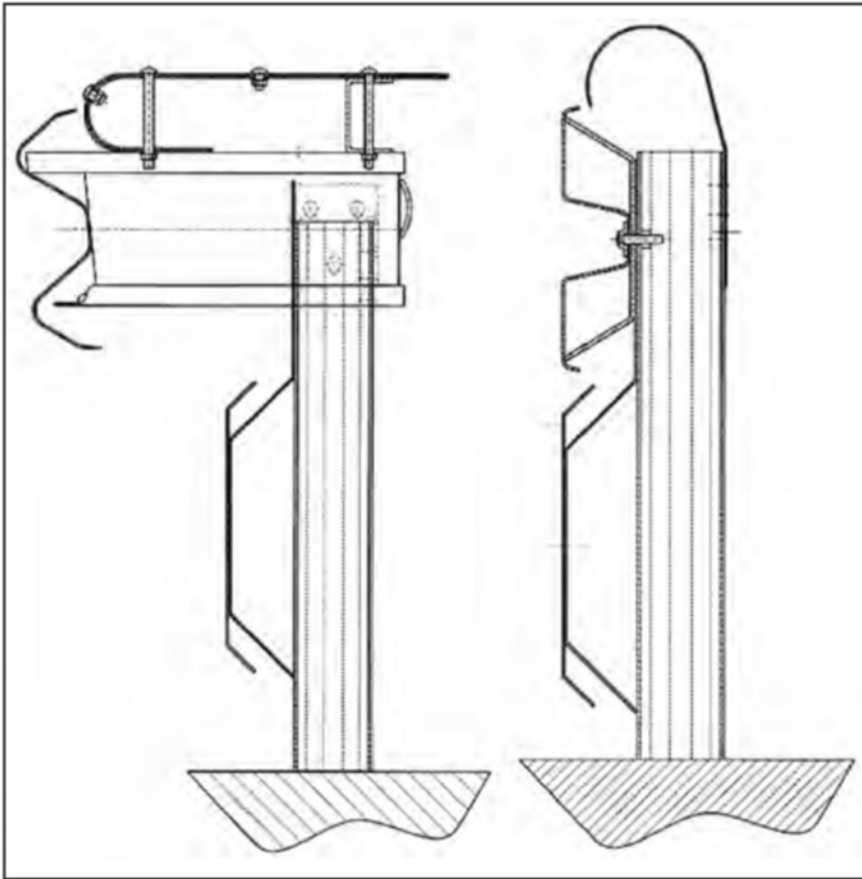
Bild 5: System EuskirchenPlus nach [GÄRTNER]

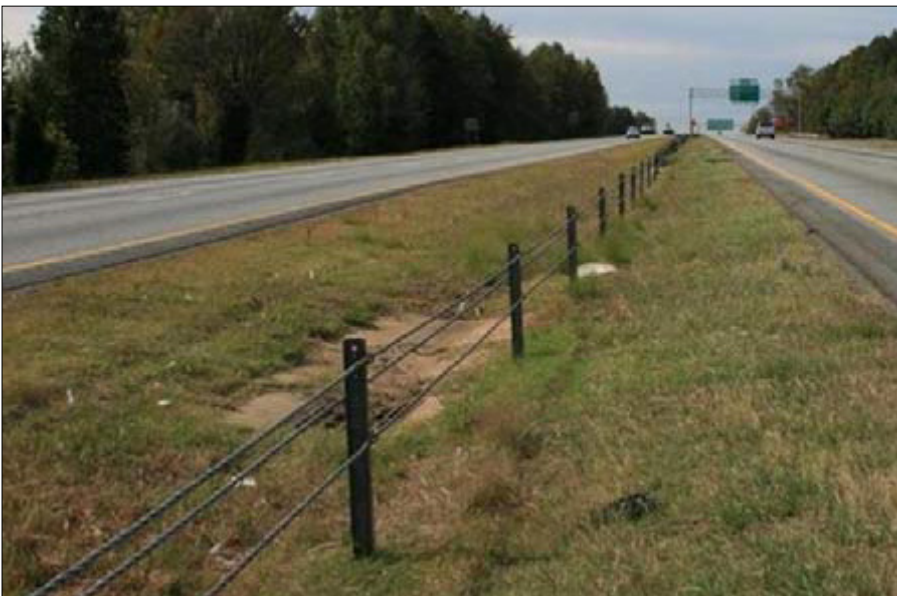
Picture 1. Median cable barrier installation in USA

One thing of Clay's presentation that drew the attention of all participants was the generous space between the road and the median barrier. An American cable barrier may also have eight meters between the posts. Cable barriers are often further from the paved edge of the road in the USA compared to both concrete and w-profile barriers which can affect the outcome of a guard rail collision positive since the speed drops before the collision with the barrier. Clay agreed with this and admitted that this had not been taken into account when looking at injury outcomes.

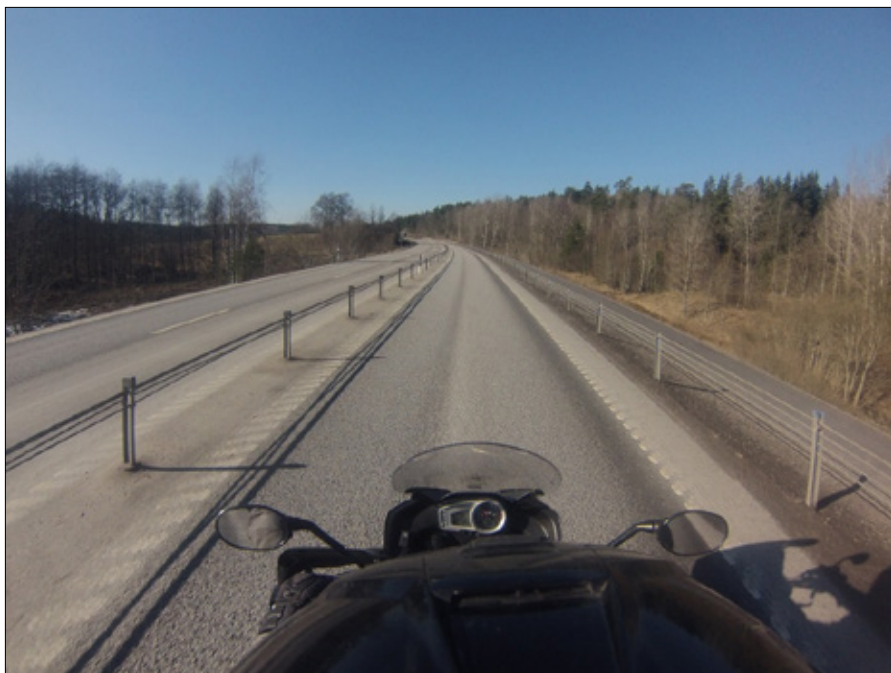
Picture 2. Cable barrier installation 2+1 in Sweden (Finspång-Norrköping).

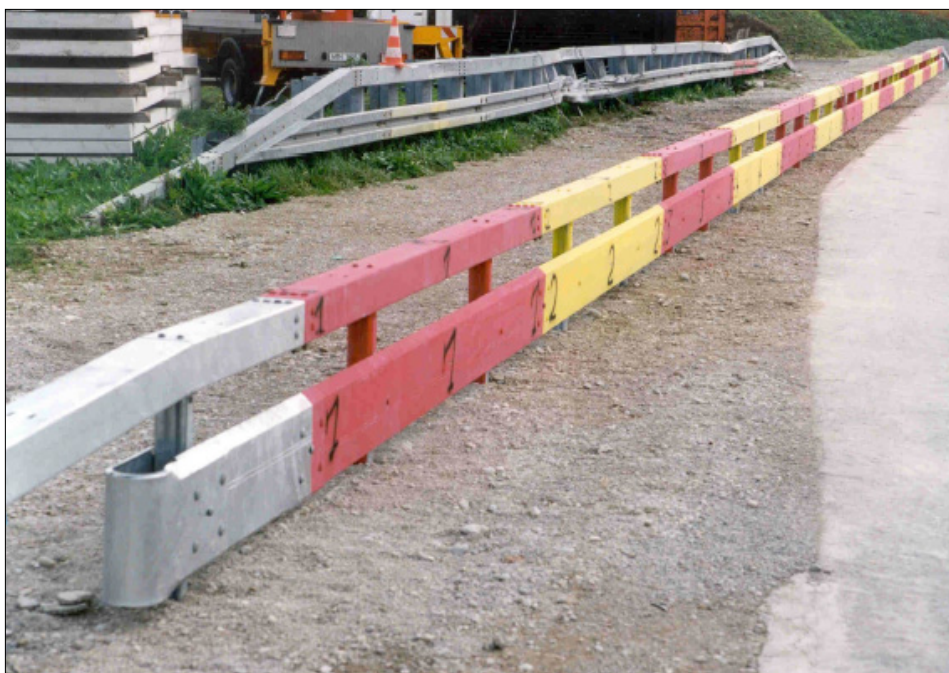
Picture 3. Box beam barrier with MPS, Germany.

The German crash tests have been made by BAST both with the dummy seated on the motorcycle and sliding into the guard rail. For BAST it is important to test both scenarios. The first MC-friendly railing that was first used was box beam barrier with MPS.
